REPORT ON
SITE SURVEY OF
ARCHAEOLOGICAL REMAINS
AT THE SITE OF
THE EAST CADIA VILLAGE,
CADIA, N.S.W.

For
Newcrest Mining Limited,
Cadia Project.

March 1997

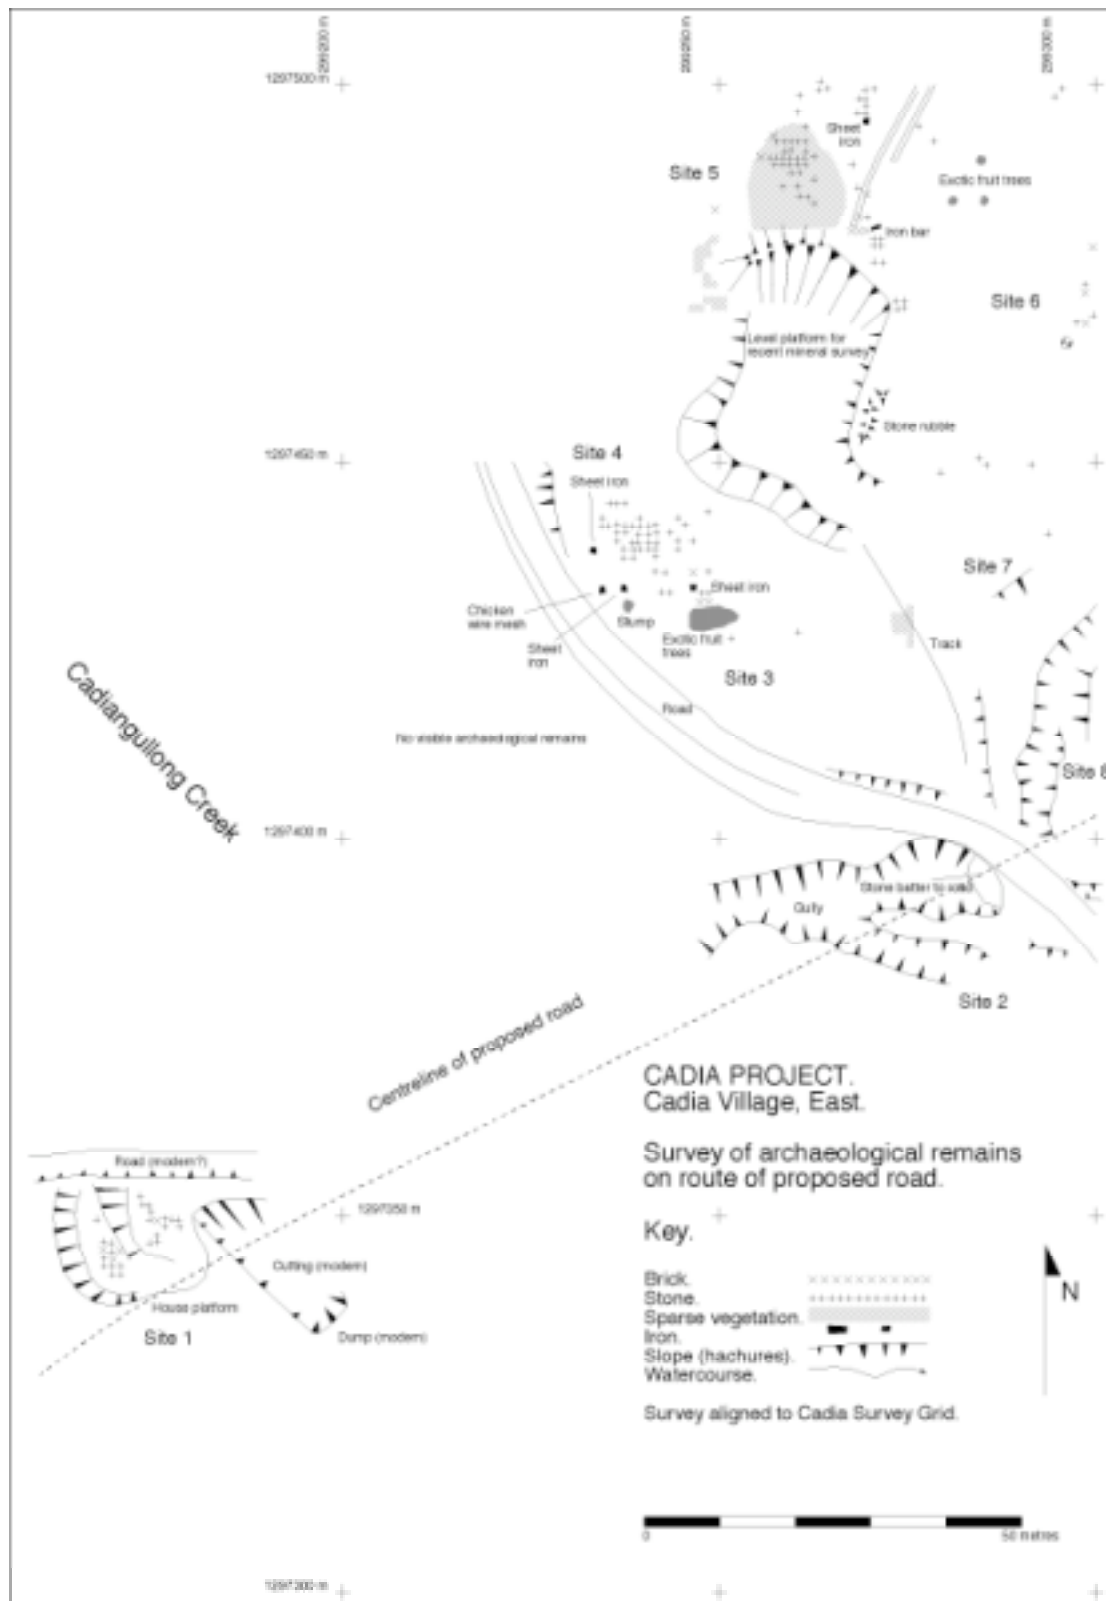
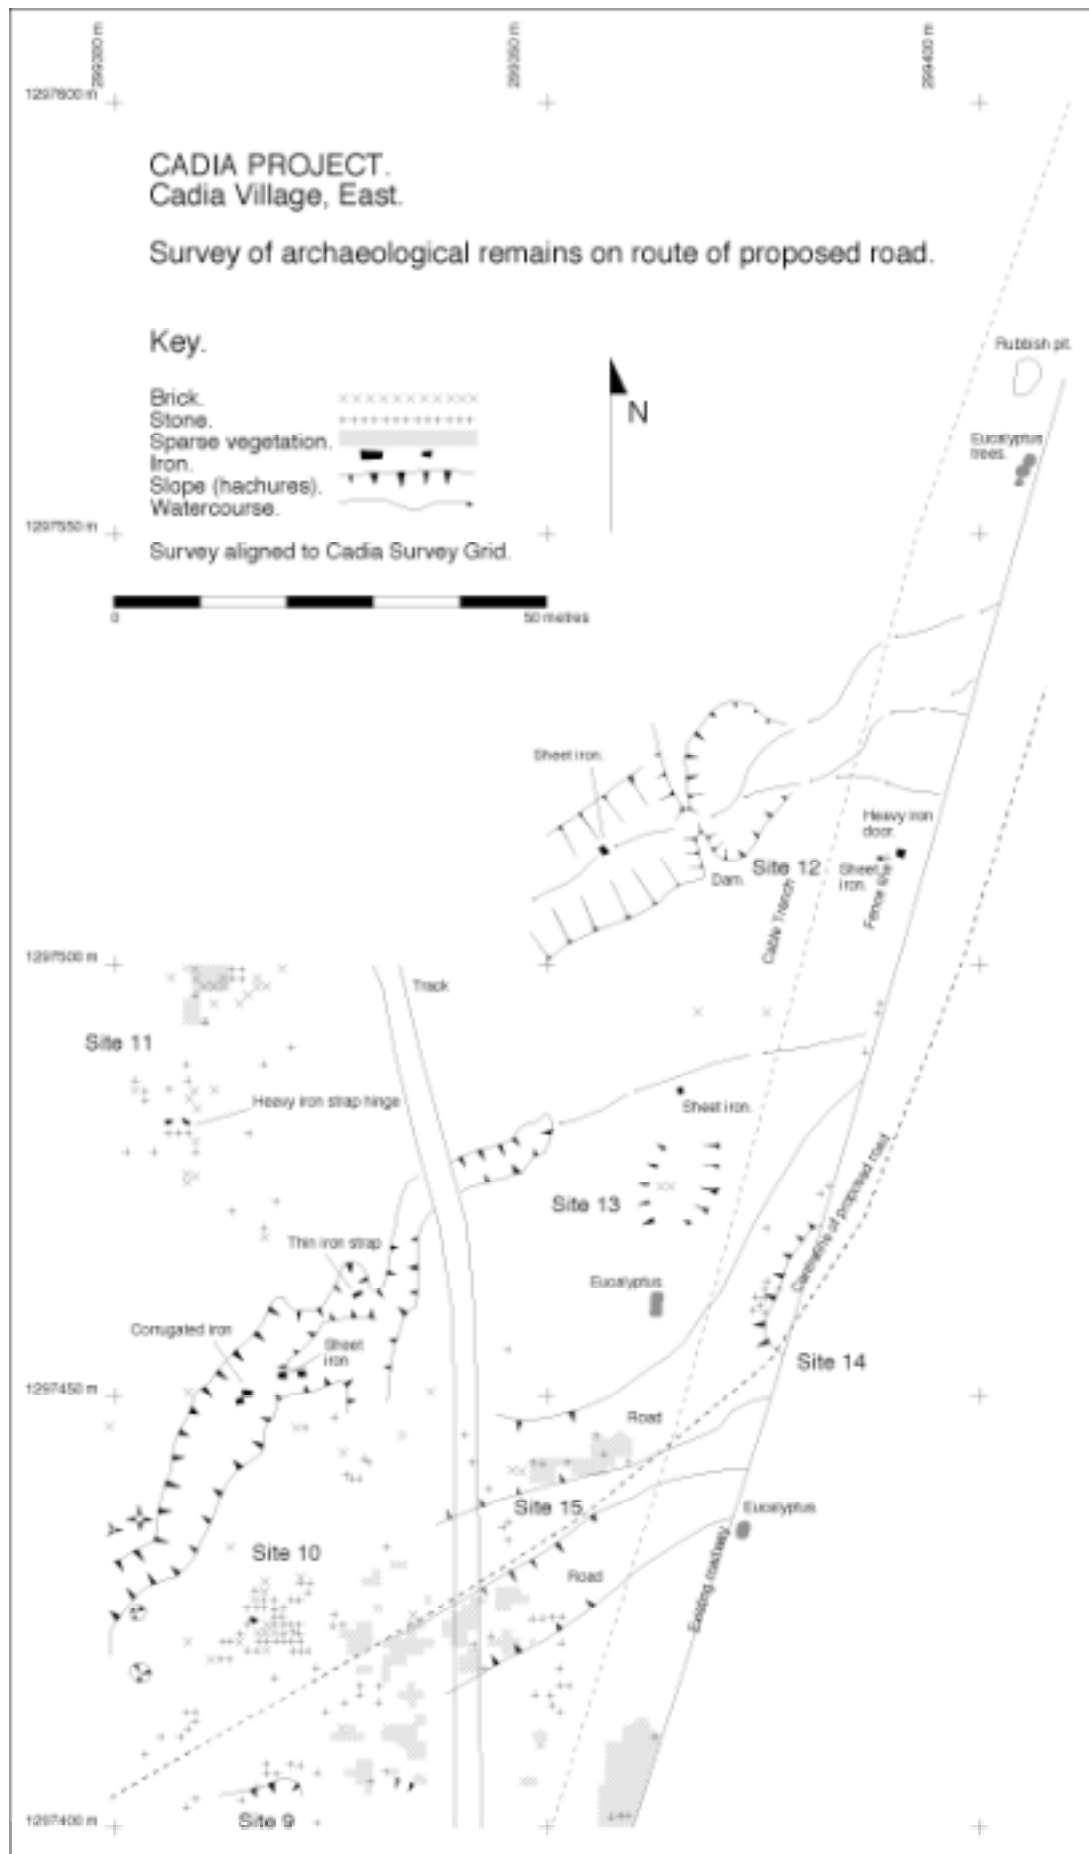
Figures 3.1 and 3.2, overleaf. East Cadia Village, detail showing course of proposed road and archaeological remains on or adjacent to the route.

Comparison of the archaeological features and artifacts with historical documentation enabled a number of sites to be identified (Figures 3.1 and 3.2). The archaeological evidence was compared with the historical photographs in the previous chapter, together with others in the Conservation Plan (Figures 2.1 to 2.4).¹³

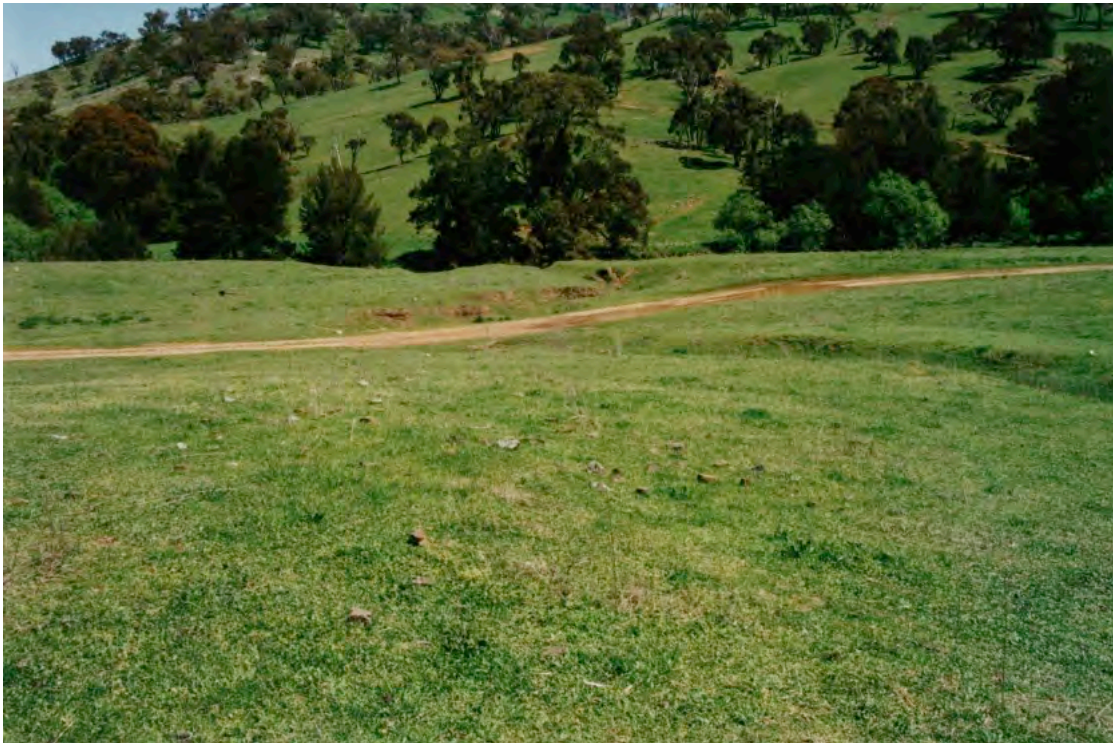
Figure 3.6. East Cadia Village Site, general view along course of proposed access road within the study area, from north east, with Cadiangullong Creek in the background. A brick scatter indicates the location of a former structure (Site 10).

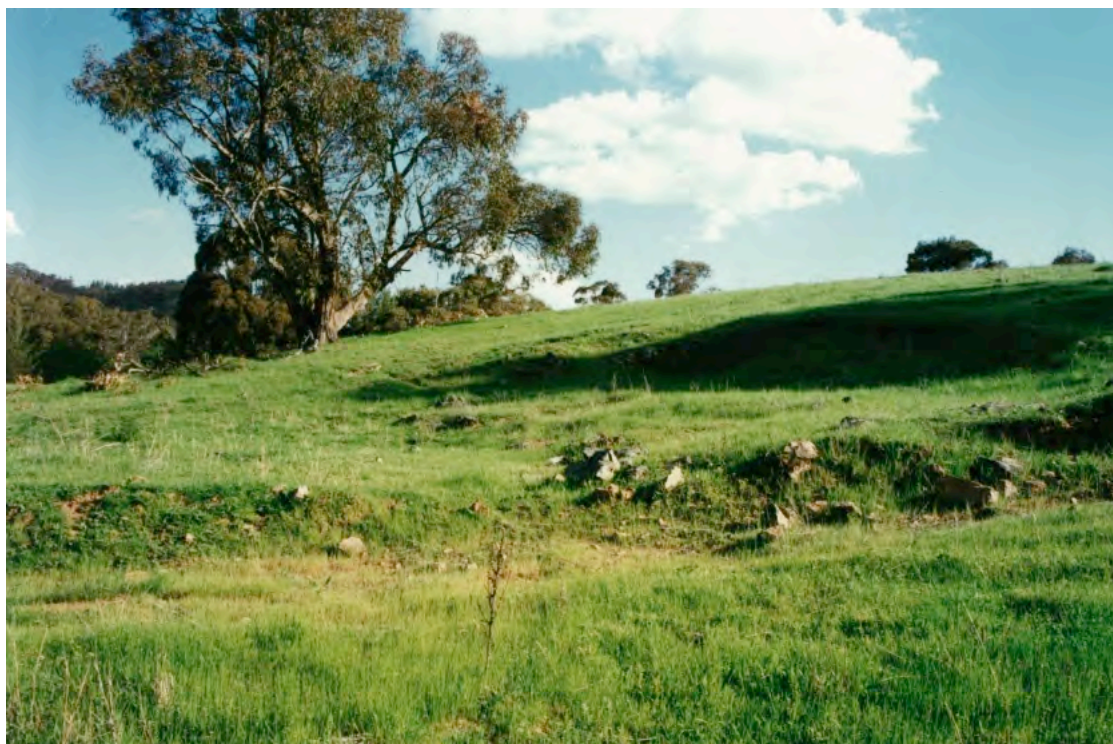
Site 1 is the house platform, located on the west side of the Cadiangullong Creek. It is identified by two levelled terraces, cut into the slope above the flood plain of the creek. The platforms have a number of stone and brick scatters on them, but the site has been disturbed by the excavation of a trench on the side of the creek and the construction of a track on its north side.

Figure 3.7. East Cadia Village Site, house platform (Site 1) on west side of Cadiangullong Creek, on course of proposed road. The house platform is largely in shadow, with a modern access road in the foreground.

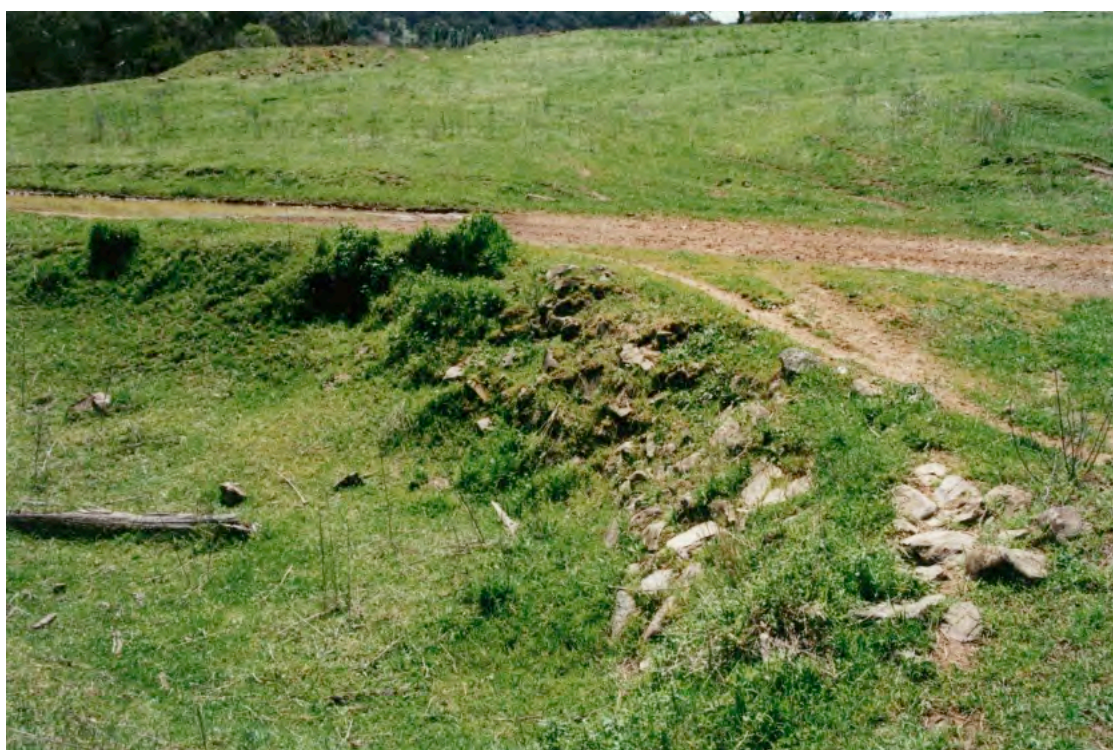
Site 2 comprises the course of a gravel or dirt road across a minor gully or watercourse (Figure 2.1). The road is revetted with a stone batter to allow water flow without erosion of the road surface. The feature compares with other examples in the Cadia area. The road itself is visible on the 1905 and later photographs.

Figure 3.8. East Cadia Village Site, stone batter on line of gravel road across a minor gully (Site 2).
