REPORT ON
SITE SURVEY OF
ARCHAEOLOGICAL REMAINS
AT THE SITE OF
THE EAST CADIA VILLAGE,
CADIA, N.S.W.

For
Newcrest Mining Limited,
Cadia Project.

March 1997

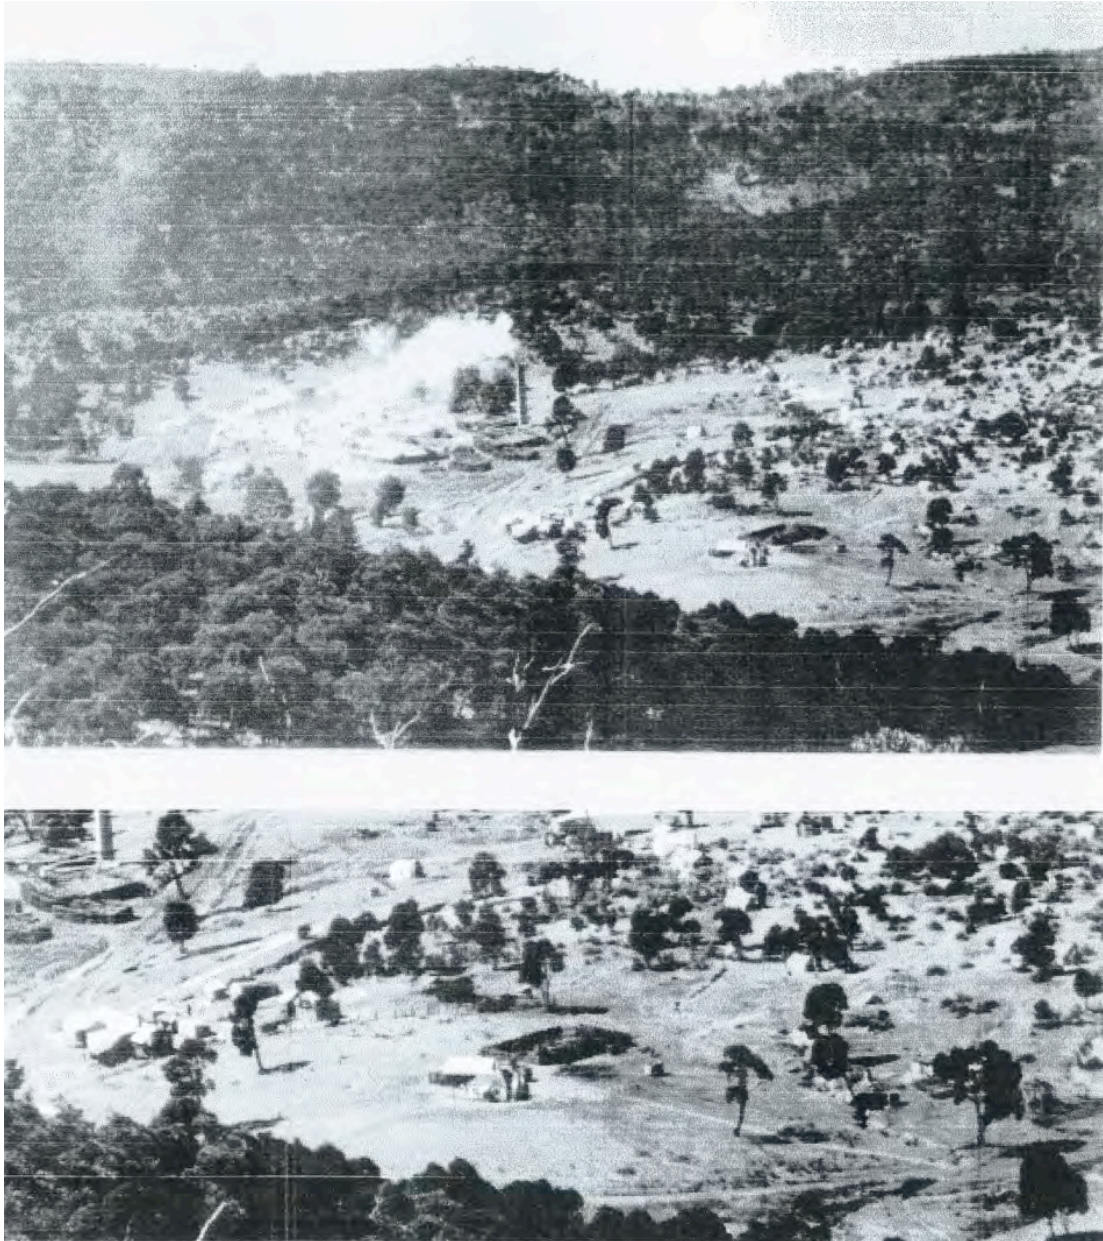
Figure 2.1. East Cadia Village from the south west, dated to 1905-6 by the operation of Smelter No. 2. Structures on the course of the proposed access road are shown on the right or in the detail below(Photograph courtesy of Brian French).

Site 2 comprises the course of a gravel or dirt road across a minor gully or watercourse (Figure 2.1). The road is revetted with a stone batter to allow water flow without erosion of the road surface. The feature compares with other examples in the Cadia area. The road itself is visible on the 1905 and later photographs.

Site 5 is visible in historical photographs, dated from 1905 onwards (Figure 2.1). It comprised a complex of buildings and other structures, probably also including Site 6. The principle structure is a hut with a hipped roof, central door and flanking windows. It has one or perhaps two chimneys on its south wall, suggesting that there may have been a skillion at the rear. Adjoining the hut is a larger gable roofed structure or building. A small fenced stockyard, or similar feature is located on the east side of the buildings, together with another smaller structure (Site 6?). (Figure 3.1).

Site 6 is visible in historical photographs, dated from 1905 onwards (Figure 2.1). It may represent the stockyard of Site 5, as described above, or the small structure to the south of the stockyard in the historical photographs.

A number of larger structures are present in historical photographs from 1905 onwards, probably including Sites 9 and 10 (Figure 2.1). Site 9 comprised a small hut, with a pitched roof and a chimney at its south end

Site 10 is visible on historical photographs from c.1905 onwards (Figure 2.1). It was a hut with a pitched roof and chimney on its south wall.

Site 11 is difficult to identify on historical photographs, and it may possibly be associated with Site 5 and 6, as indicated on historical photographs from c.1905 onwards (Figure 2.1).

Site 12 is indicated by the presence of a number of artifacts, including a heavy iron door and other fragments of sheet iron. It is not possible to identify any structure with certainty in the historical photographs, although it appears to be in a similar location to a tent like structure (Figure 2.1). The historical and archaeological evidence appear to be incompatible, and it may be suggested that the door has been left behind during the collection of scrap or other items from the site. The iron door may have had an industrial usage.

It may possibly be identified as the timber frame in the c.1905 historical photograph, with its roof placed beside it (Figure 2.1). The structure is no longer present by c.1910.¹⁸

Sit 14 may be a remnant of a cottage and other outbuildings, visible in the c.1905 historical photograph (Figure 2.1). The building appeared to be a small cottage with

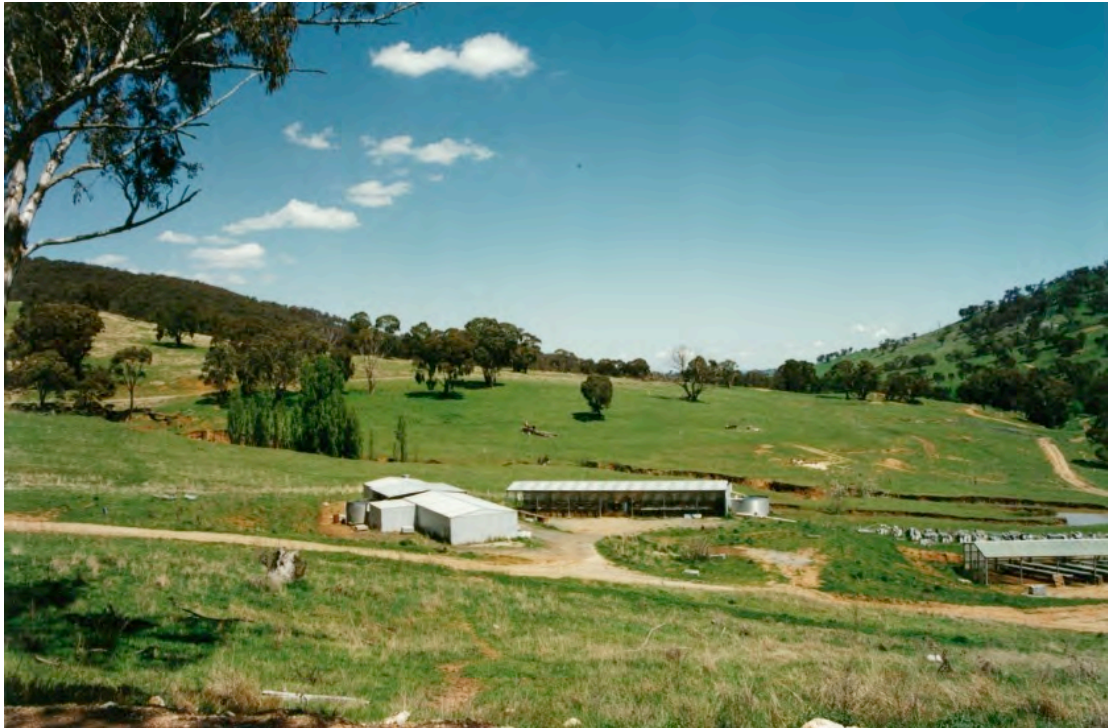
Figure 3.3. East Cadia Village Site, general view from north, with Cadiangullong Creek on right.
Figure 3.4. East Cadia Village Site, general view from west, showing existing access road and other tracks. The study area is in the vicinity of the junction of the three gravel roads or tracks on the east side of Cadiangullong Creek.

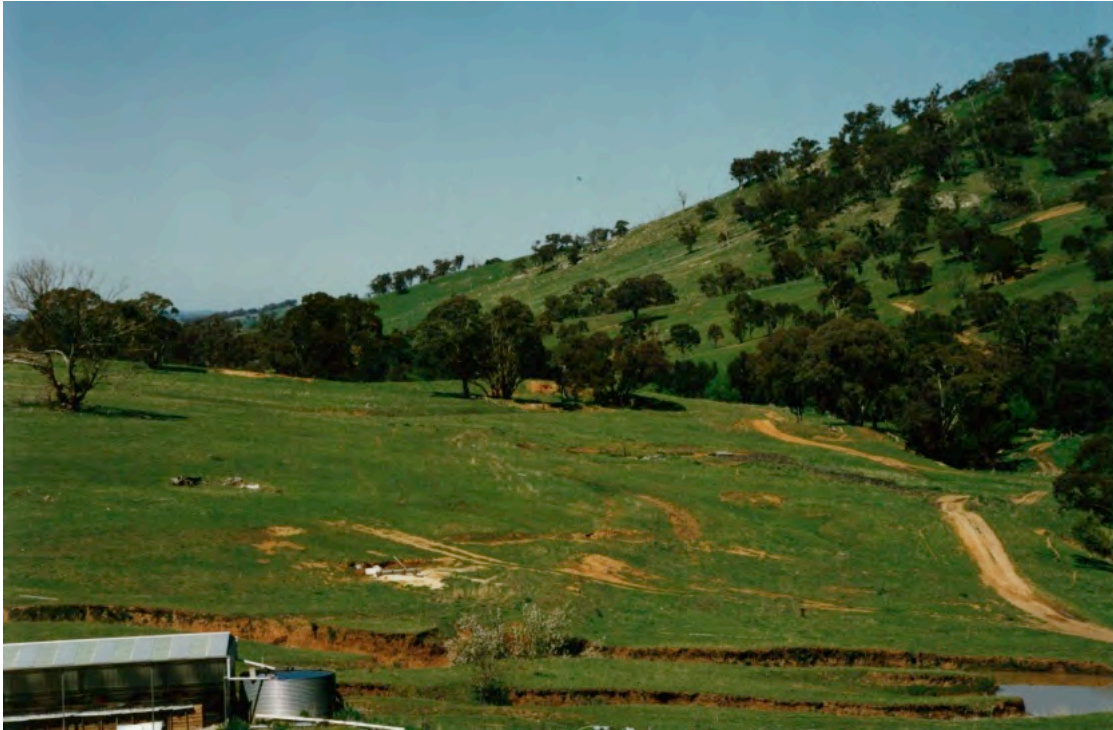
Figure 3.5. East Cadia Village Site, general view from north, with the remains of Smelter No. 2 in the right middle of the photograph.

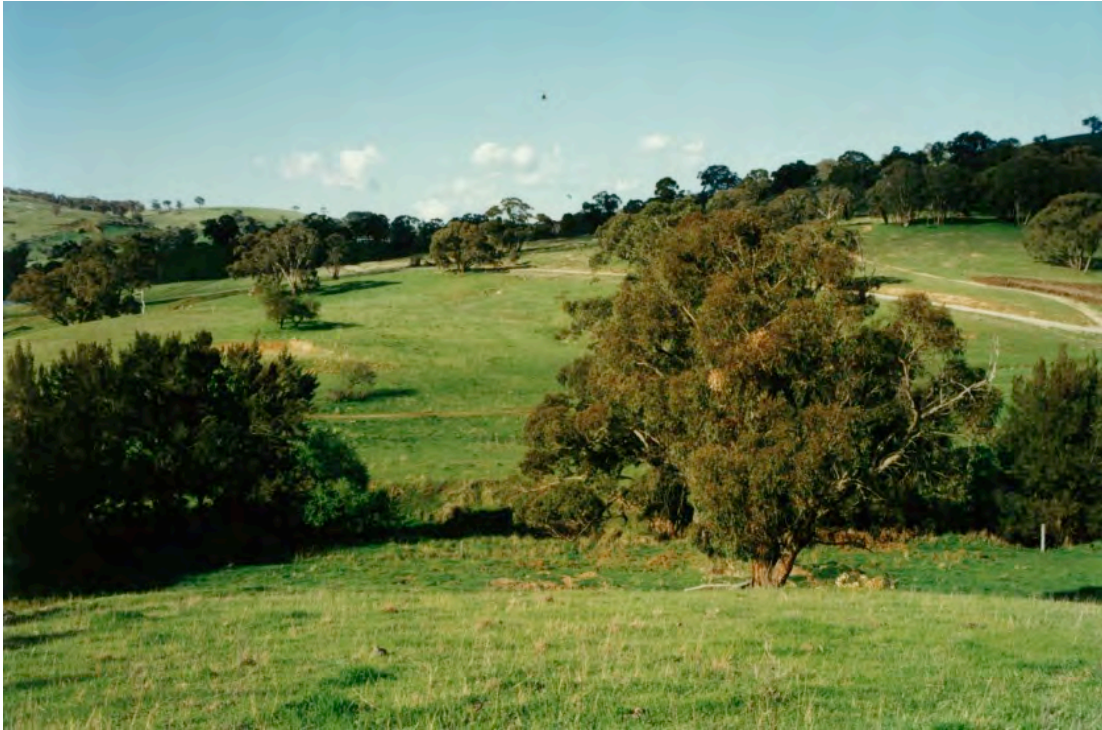
Figure 3.9. East Cadia Village Site, general view along course of proposed access road within the study area, from the south west, with Cadiangullong Creek in the middle of the photograph. The house platform (Site 1) in Figure 3.7 is located to the left of the tree in the foreground.

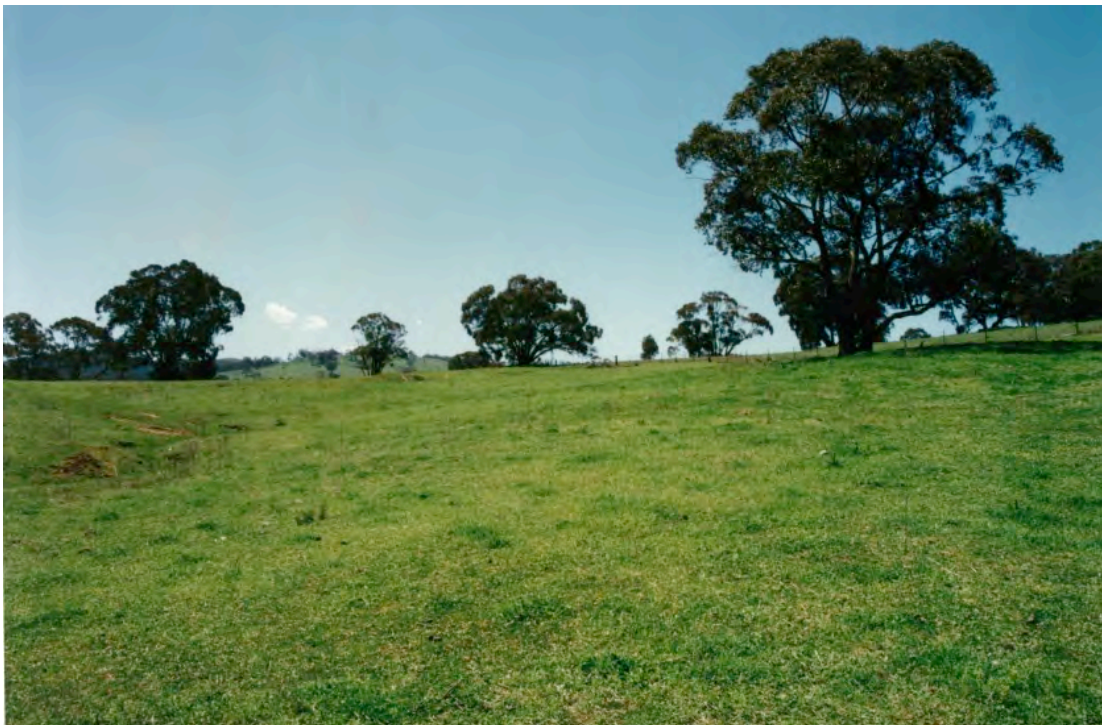
Figure 3.10. East Cadia Village Site, general view along course of proposed access road within the study area, from the south west, but on the east side of Cadiangullong Creek.
